**Report on the Investigation of the Effect of Fire
on Asbestos Fibre Contamination
Department of Human Services**

November 2006

Report on the Investigation of the Effect of Fire on Asbestos Fibre Contamination

Department of Human Services

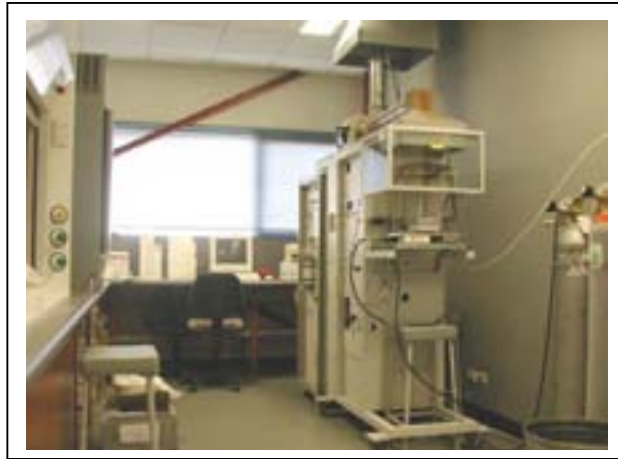
The specimens of A/C sheeting were tested under elevated temperatures using the cone calorimeter at the Centre for Environmental Safety and Risk Engineering at Victoria University. This apparatus is shown in Figure 1 and was used to expose A/C test specimens of approximate size 100mm x 100mm to three levels of radiant heat (namely; 50kW/m², 75 kW/m² and 100kW/m²) whilst allowing sampling of the air above the heated specimen.

Figure 1 Cone Calorimeter

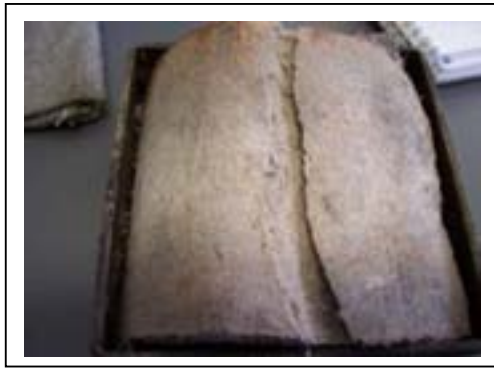
Spalling occurred for all test specimens except two. The result of the spalling varied, from specimens being fractured in two (Figure 5(a)) to pieces being ejected from the specimen (Figure 5(b)).

Figure 5(a) Splitting of specimen

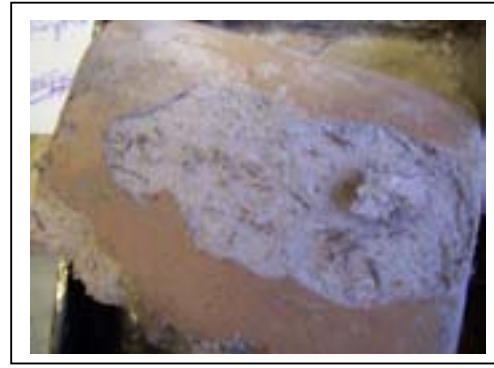
Figure 5(b) Loss of parts of specimen

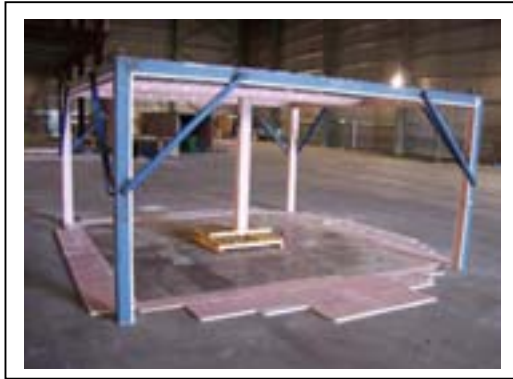
A test rig was designed to support the A/C sheeting and was constructed of structural steel with steel mesh between the roof beams to provide direct support to the A/C sheeting that was placed directly onto the mesh. The mesh was welded around the edges to the edge beams to permit the mesh to utilise catenary action under fire conditions. The edge beams were designed to resist the resulting horizontal forces. The steelwork was protected with fire-resistant plasterboard to ensure that sufficient strength was maintained throughout the fire. A photograph of the test rig prior to placement of the A/C sheeting on the reinforcing mesh is shown in Figure 7. The height of the rig was 2.1m whilst the plan dimensions were 4m x 4m. This meant that approximately 16m² of A/C sheeting could be supported approximately 2m above the floor.

Figure 7 Supporting Structure

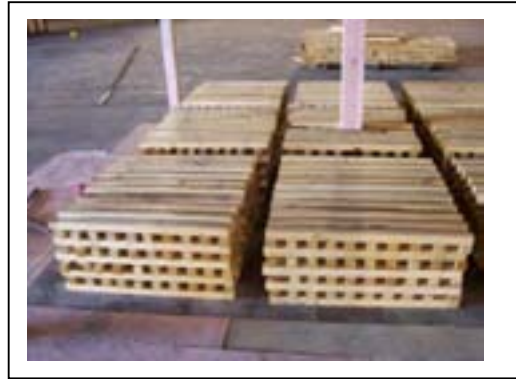
Figure 7a Fuel in form of wood cribs

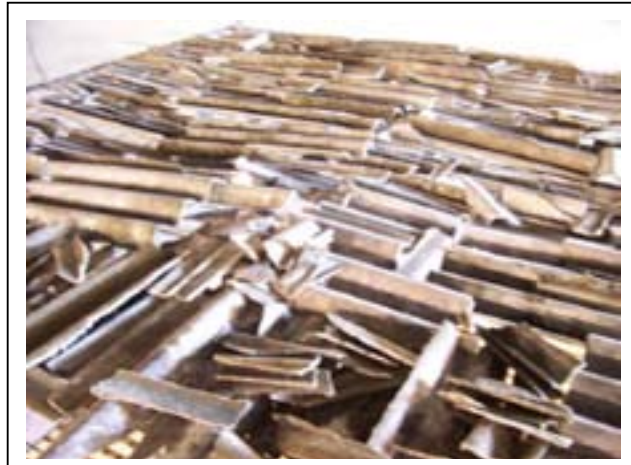
Figure 8 shows the A/C sheeting after it was placed on the test rig. Prior to testing, a fine steel protective mesh was placed over the *top* of the A/C sheeting to assist in confining fragments of A/C sheeting that might be ejected due to spalling during the fire, see Figure 9.

Figure 8 A/C sheeting placed on test frame

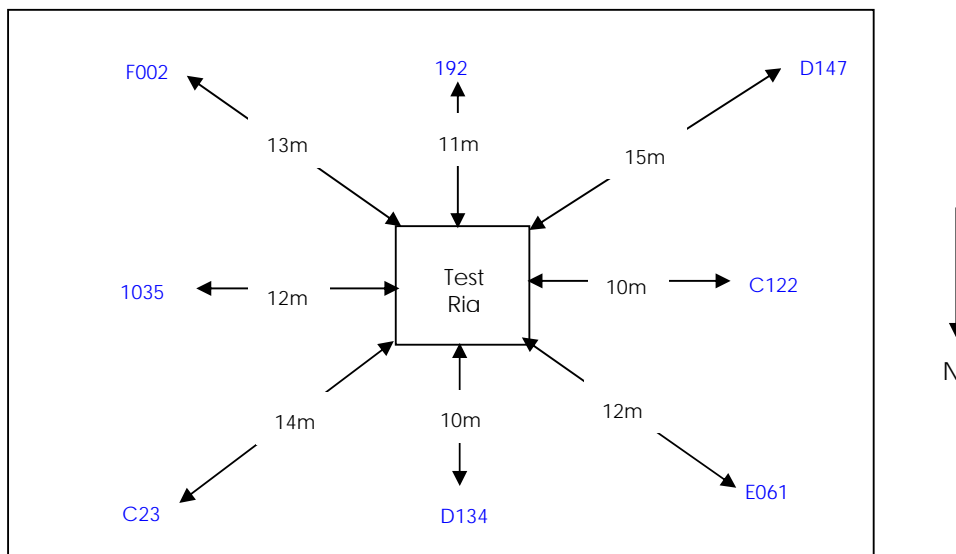
Additional filter measurements were taken near ground level within the building and 25mm filters were also used. In total there were eight ground level filter-monitoring pumps located as detailed in Figure 11. These filters were replaced approximately 25 minutes after the fire had been ignited, when the spalling had ceased. The replacement filters were used until the test ended. The total monitoring period for the replacement filters was approximately 3.5 hrs.

Figure 11 Ground Level Filter Monitoring Pump Locations, in blue

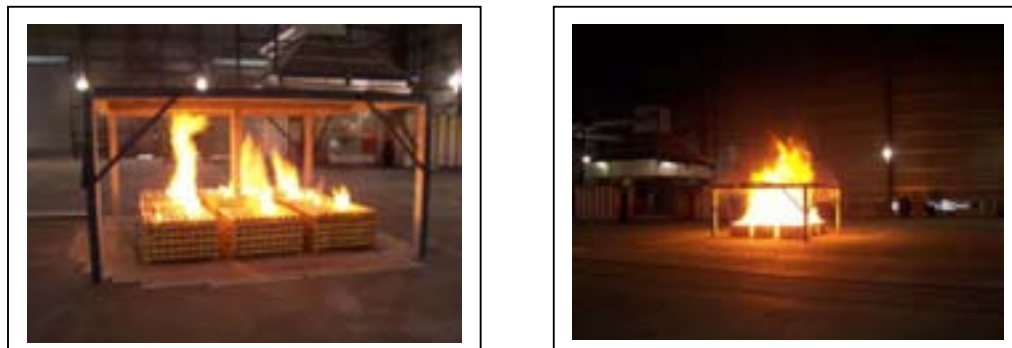
Figure 12 shows the fire shortly after ignition and then during its fully developed stage of burning.

Figure 12 Early fire development and established burning

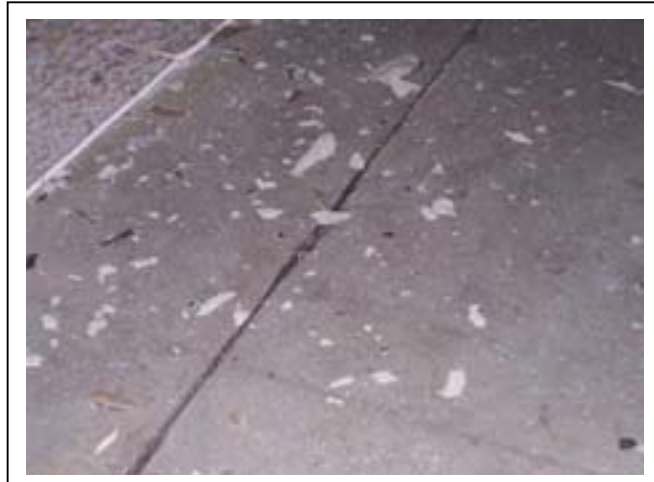
Loud explosive spalling was experienced throughout the initial phases of the fire test, with pieces of A/C sheetting being projected from the supported structure. Much of this spalled material was contained by the fine protective mesh placed over the top of the A/C sheetting, however some pieces were projected from the underside of the A/C sheetting and landed away from the test rig (see Figure 15). Pieces of A/C sheetting were found as far away as 5m from the test rig.

Figure 15 Spalled pieces of A/C sheeting on floor, away from Test Rig

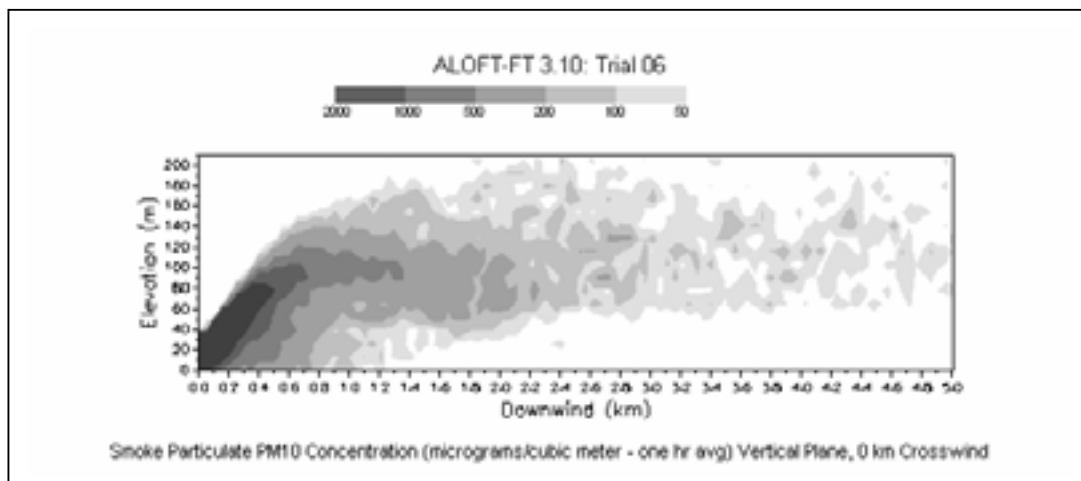
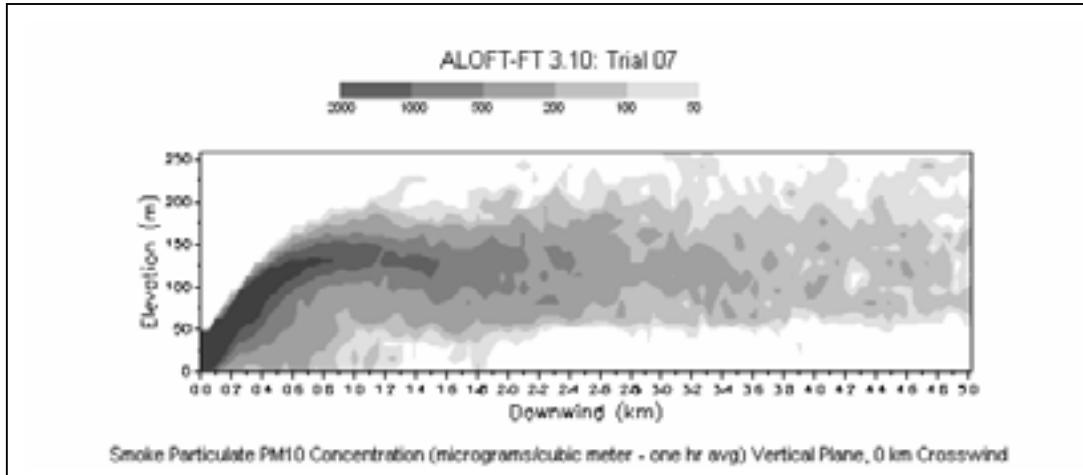
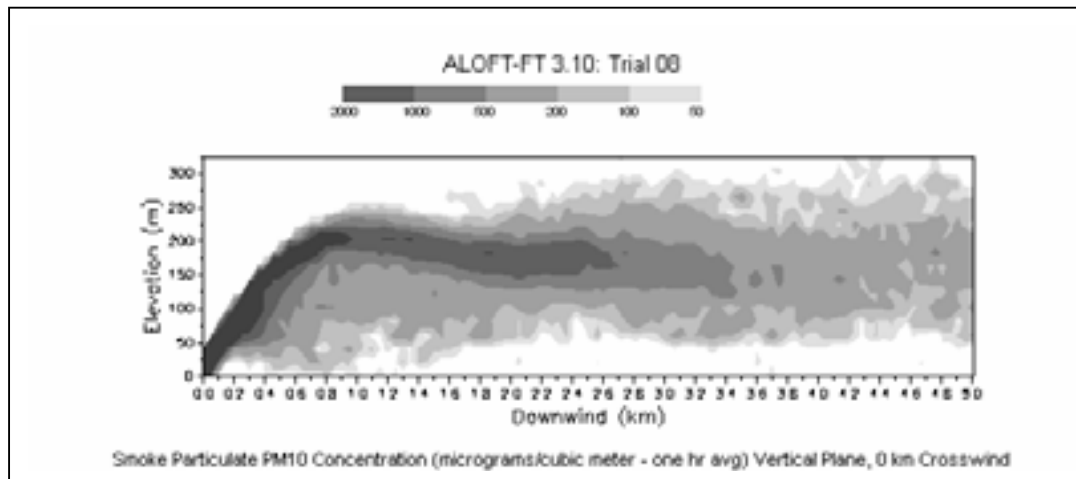
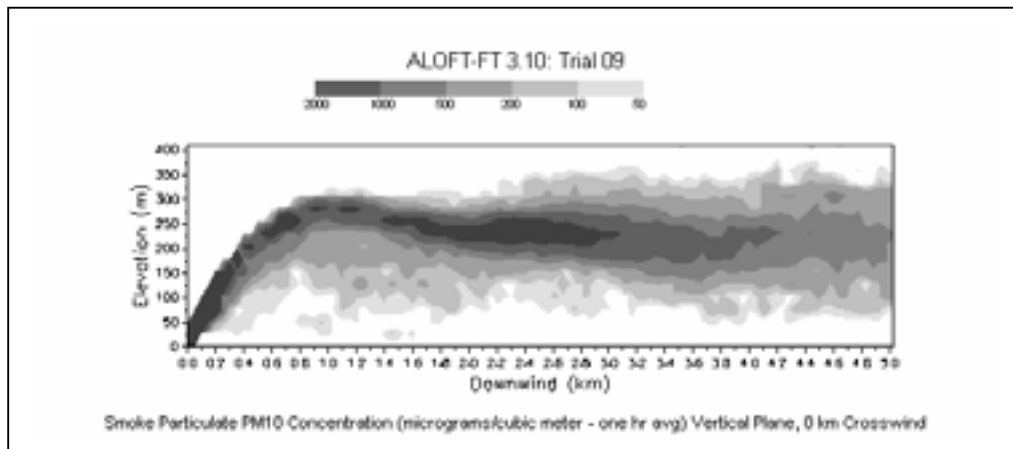
The longitudinal section plots showing the distributions for PM10 particles for a wind speed of 7m/s, are shown in Figures 19(a) – (d) for fires increasing in severity from 25MW to 200MW. Each of the fires is assumed to be steady state and the concentrations are those averaged over a one hour period. The vertical axis of each graph is in metres whilst the horizontal axis has the units of kilometres and covers a range of 5km. The concentrations are indicated by the bar chart at the top of the graph and are expressed in micrograms per cubic metre of air. The dynamics of PM10 particles represent the dynamics of respirable asbestos fibres. Therefore, the relative concentrations of PM10 reflect those that would be expected for respirable asbestos fibres.

It should be noted from these figures that as the fire increases in severity, there is a lesser likelihood of PM10 particles (which are representative of respirable asbestos particles) contaminating close to the ground level. At 100MW, the concentrations at ground level are very low, even quite close to the fire.

Figure 19(a) Vertical Slice – 7m/s and 25MW fire

Figure 19(b) Vertical Slice – 7m/s and 50MW fire

Figure 19(c) Vertical Slice – 7m/s and 100MW fire

Figure 19(d) Vertical Slice – 7m/s and 200MW fire

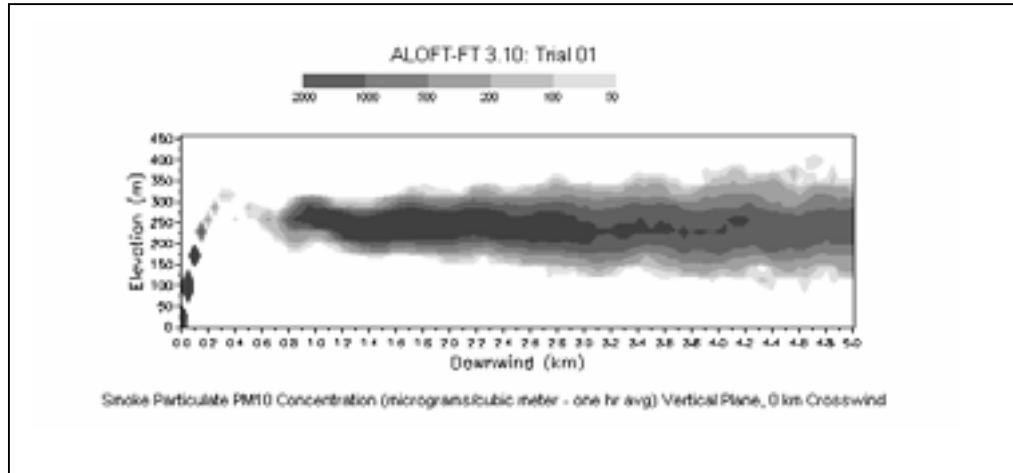
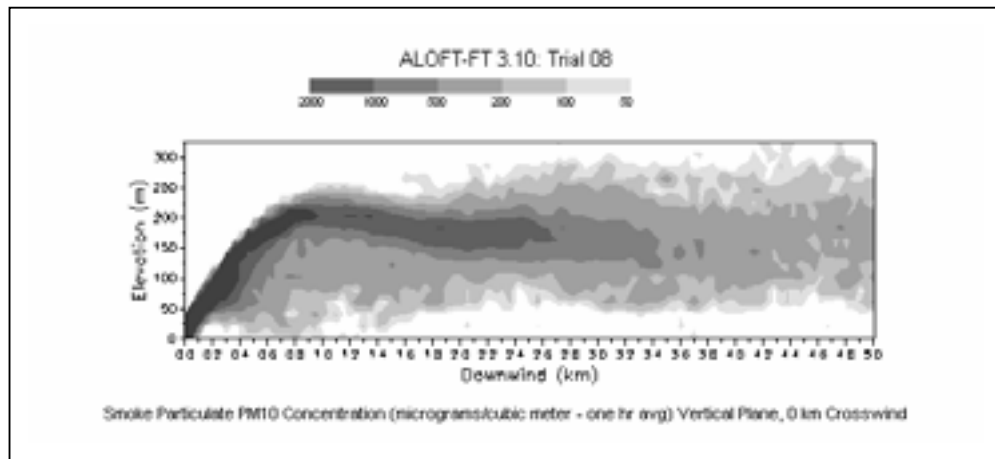
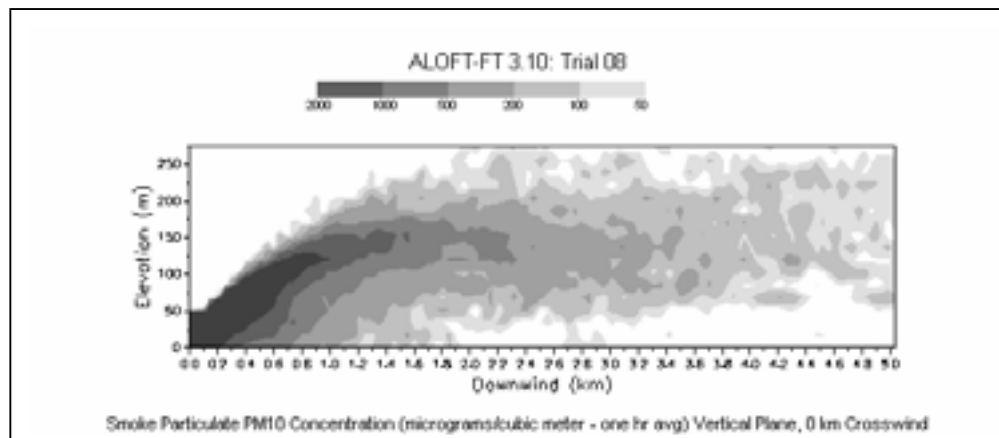
Figures 20(a) – (c) show vertical sections through the dispersed PM10 particles with increasing wind speed. These figures show that as the wind speed increases, the PM10 particles are pushed closer to the ground such that contamination at ground level occurs for over a kilometre from the site of the fire. The significance of these concentrations in respect of respirable fibre concentrations is considered in Section 6.5.

Figure 20(a) Vertical Slice – 2.5m/s and 100MW fire

Figure 20(b) Vertical Slice – 7m/s and 100MW

Figure 20(c) Vertical Slice – 12m/s and 100MW

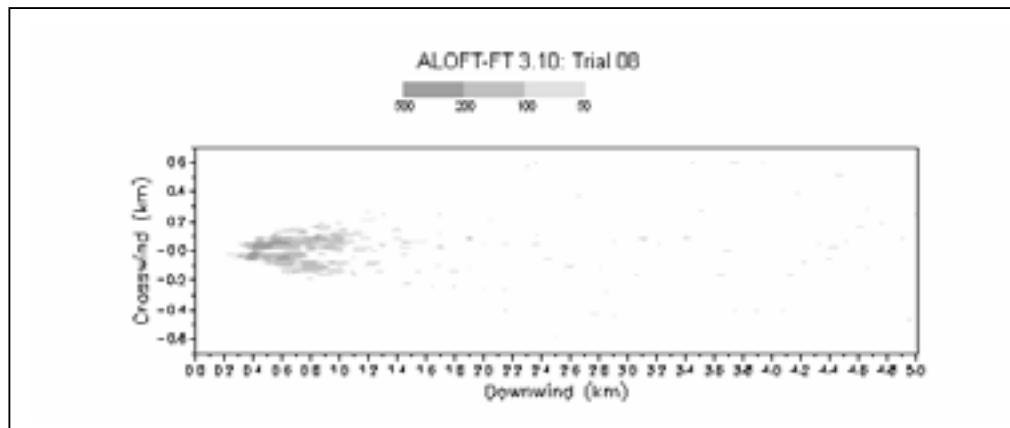
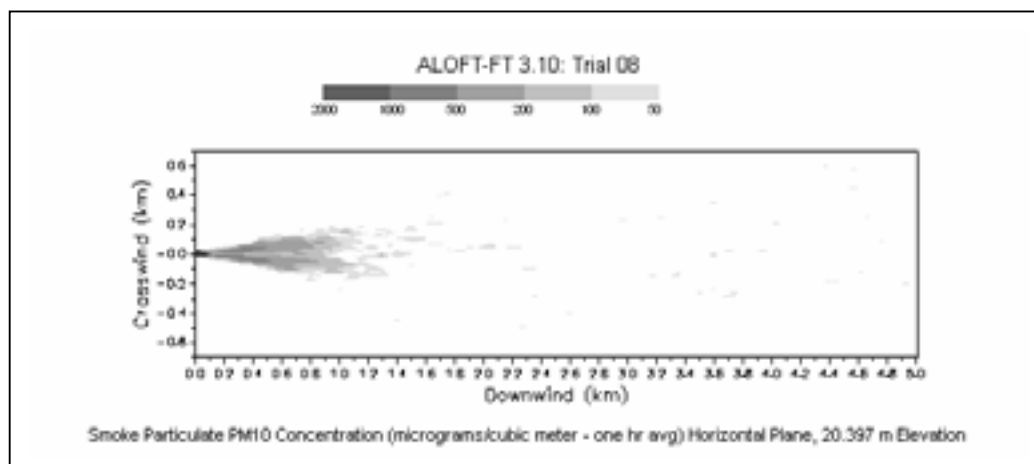
Figures 21(a) and (b) show horizontal sections through the dispersed PM10 particles at ground level and at a height above ground level. These figures illustrate how localised (in plan) the distribution of smoke particles is for a 100MW fire and a wind speed of 7m/s. Figure 22(a) and (b) show the similar horizontal sections through the dispersed PM10 particles for a wind speed of 12m/s.

Figure 21(a) Horizontal Slice at Ground Level – 7m/s and 100MW fire

Figure 21(b) Horizontal Slice above Ground Level (21m) – 7m/s and 100MW fire

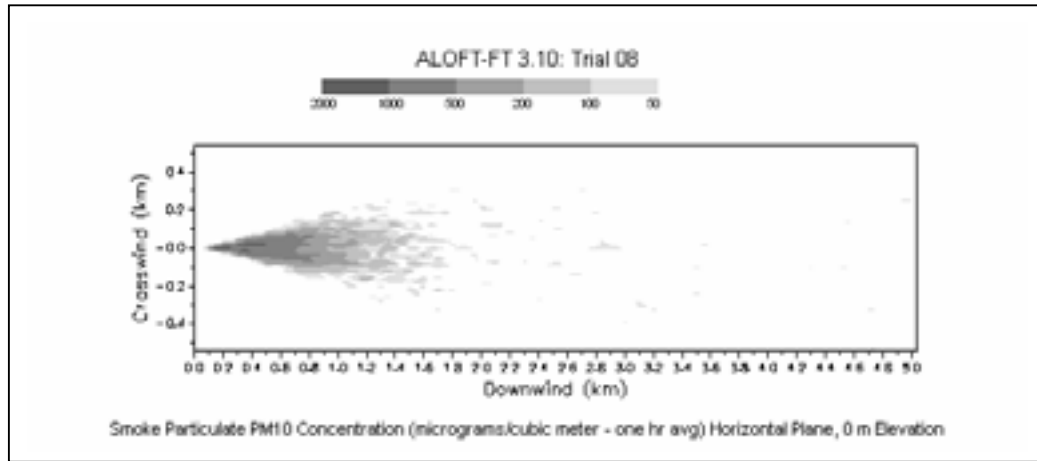
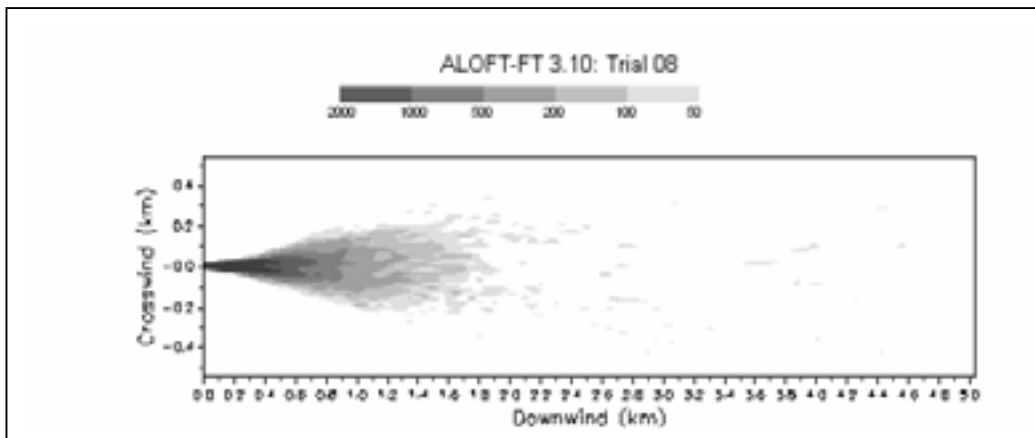
Figure 22(a) Horizontal Slice at Ground Level – 12m/s and 100MW fire

Figure 22(b) Horizontal Slice above Ground Level (17.5m) – 12m/s and 100MW fire

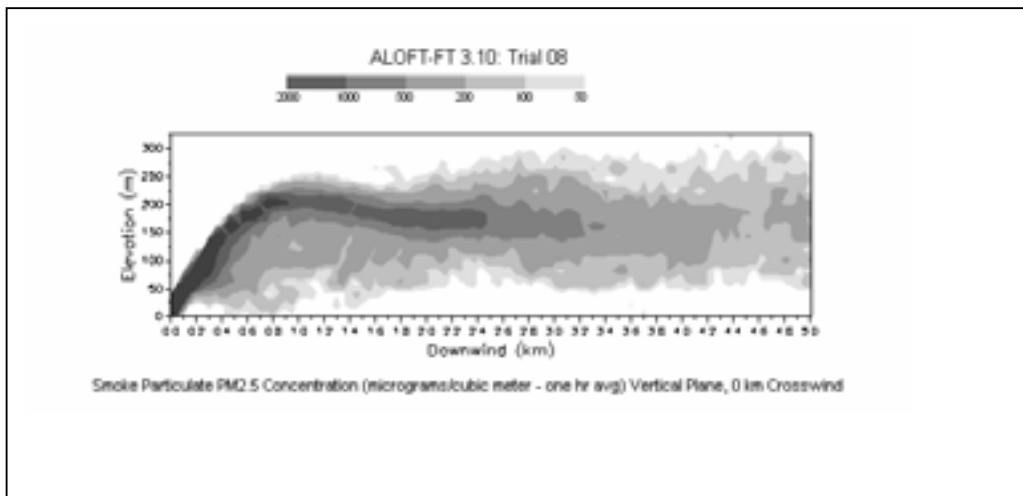
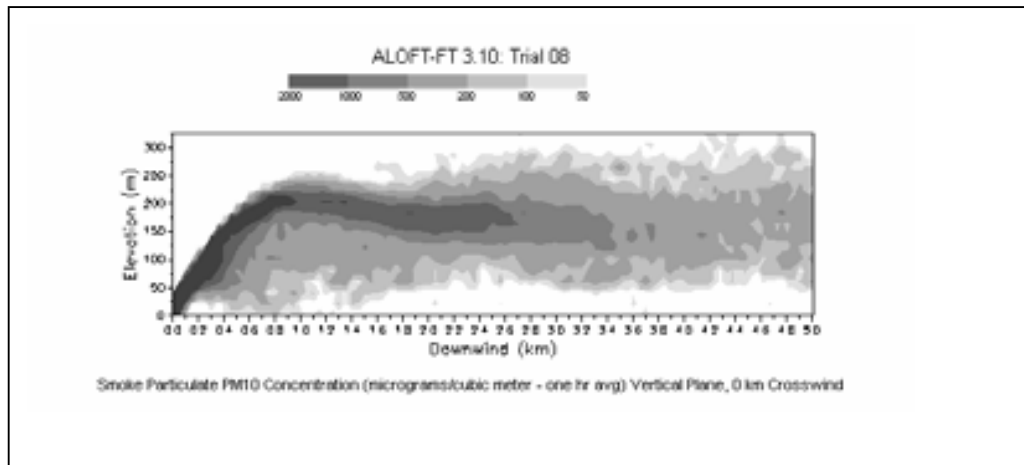
The difference in the distribution of PM2.5 and PM10 smoke particles is shown in Figures 23(a) and (b) for a wind speed of 7m/s and a 100MW fire. It is difficult to see much difference in the distribution of particles. The relative distribution of PM10 particles will be taken as representative of that which would be expected for respirable asbestos fibres.

Figure 23(a) Vertical Slice (PM2.5) – 7m/s and 100MW fire

Figure 23(b) Vertical Slice (PM10) – 7m/s and 100MW fire
